Manhole Inspection Summary

Manhole # S35QQ1015MH

Insp Date: **3/20/07 12:44 PM**

Location Address: **402 WINSTON AVE**

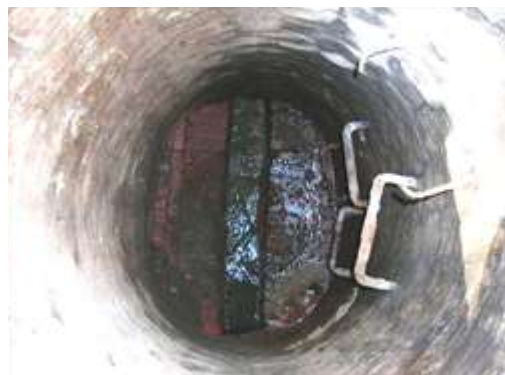
Top View

Corroded and missing steps. Evidence of surcharge - Bench debris. Channel debris.

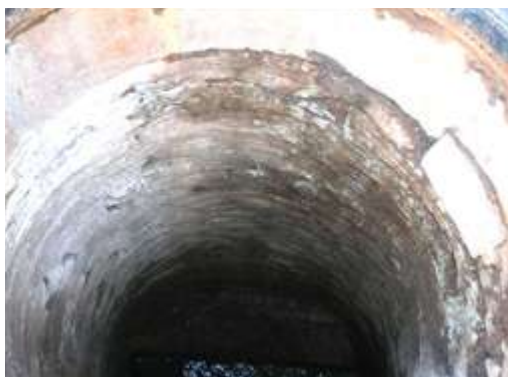
Defect

Frame leaks. Adjustment deterioration, loose brick and infiltration. Barrel infiltration - other side.

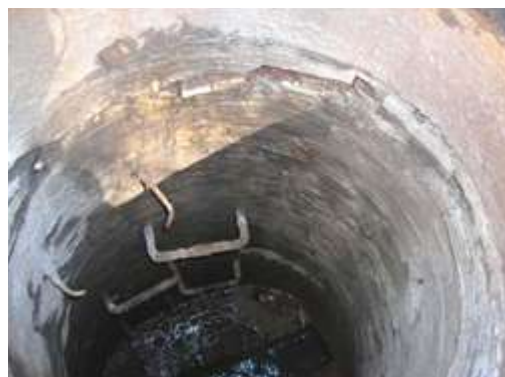
Defect

Frame leaks. Adjustment deterioration, loose brick and infiltration. Barrel infiltration.

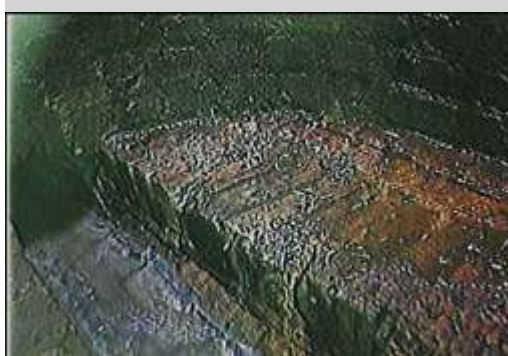
Defect

Barrel deterioration and infiltration. Channel deterioration.

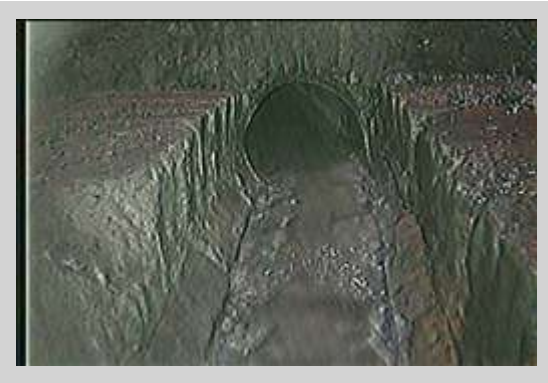
Pipe Out @ 12 O'Clock

Barrel deterioration and infiltration. Channel deterioration.

Infiltration: **Evidence** Pipe Seal Cond: **Cracked**

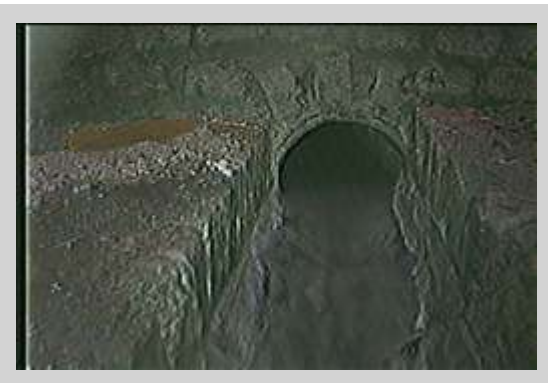
Pipe In @ 6 O'Clock

Barrel deterioration and infiltration. Channel deterioration.
